SERVICE BULLETIN

SB-8-628-001

ATTENTION: SERVICE MANAGERS / PARTS MANAGERS
SUBJECT: CHANGING POSITION OF WIPER ARMS

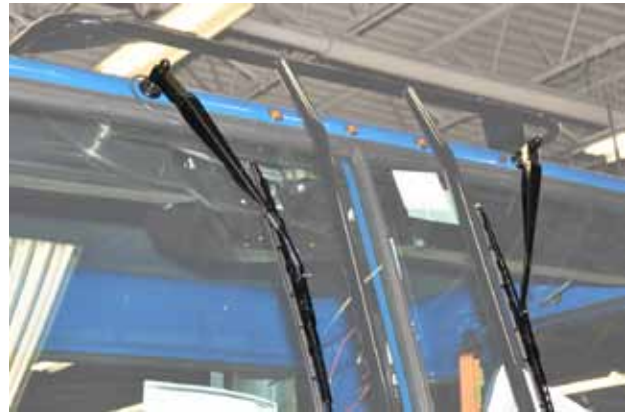
Figure 1

This bulletin provides instructions for changing the position of the wiper arms from the as-shipped at-rest position to the opposite at-rest position (see *Figure 1* (vertical) and *Figure 2* (horizontal)).
