SB 3-873-002

SUBJECT: INTERMITTENT SHUTDOWN OF TRANSMISSION ECU ON WX TRUCKS WITH NEW DASH

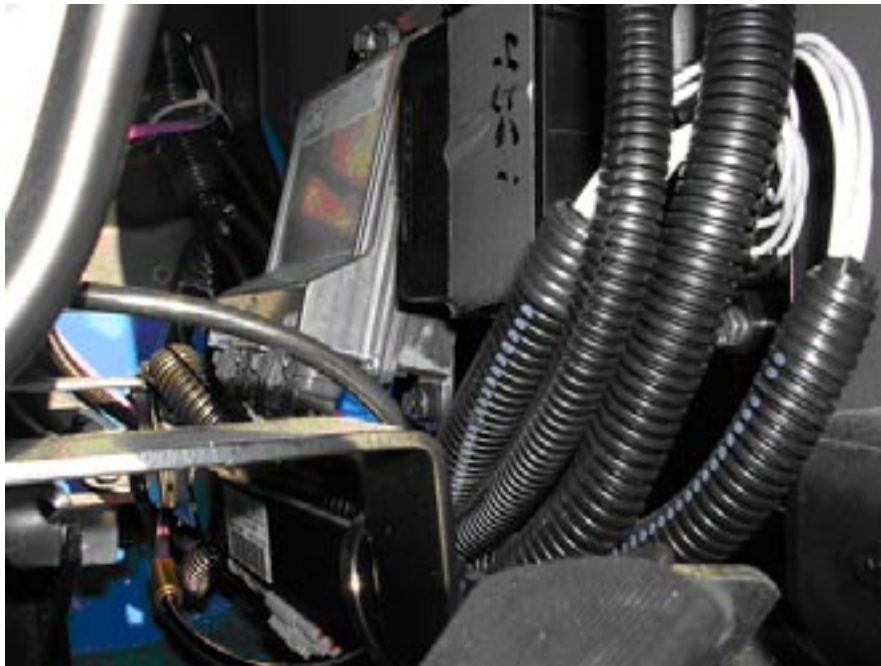
Figure 1

The root cause has been determined to be incorrect routing of the transmission ECU and main cab harness behind the LH seat. The wiring behind the seat at or near the transmission ECU contacts the seat as it travels, which causes the connectors to be unplugged and or damaging (chafing) the wiring harness. See **Figure 1** and **Figure 2**.

INCORRECT ROUTING, WIRING IN CONTACT WITH SEAT

1. Park the vehicle on a level surface. Turn off the engine, apply the parking brakes, and chock the rear tires to keep the vehicle from moving.
2. Locate the transmission ECU behind the LH seat.
3. Reroute the harnesses to the side and over the top of the transmission ECU and secure with cable ties and cushioned loom clamps. See **Figure 3** and **Figure 4** on page 5.
4. Repair any chafed wires and secure any loose connectors.

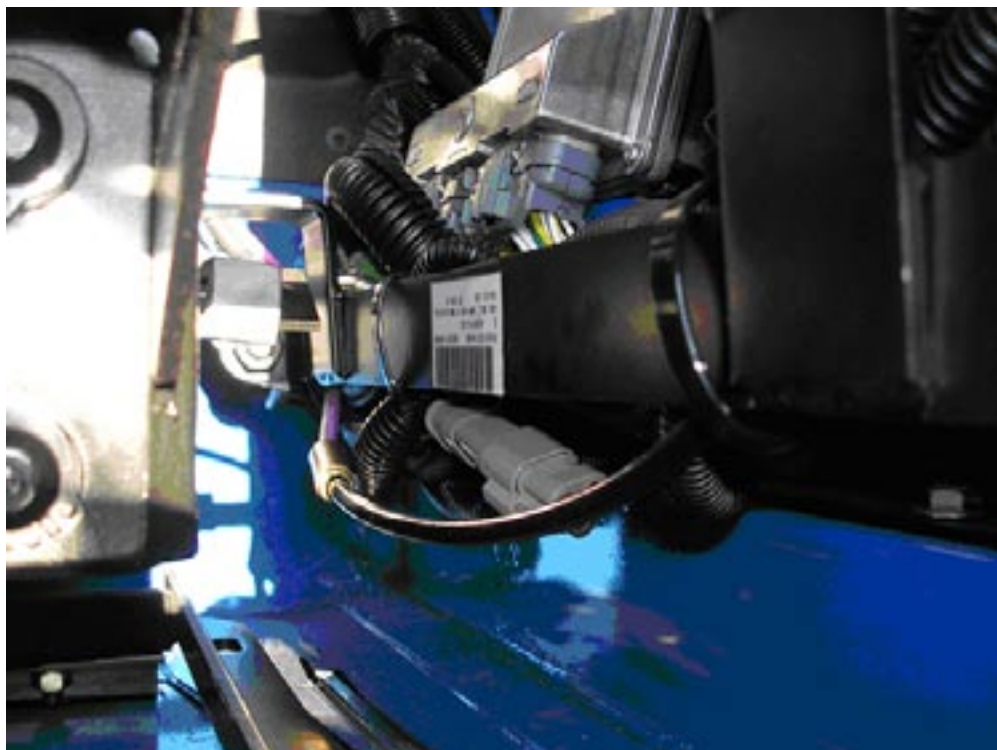
Figure 2

INCORRECT ROUTING, WIRING IN CONTACT WITH SEAT

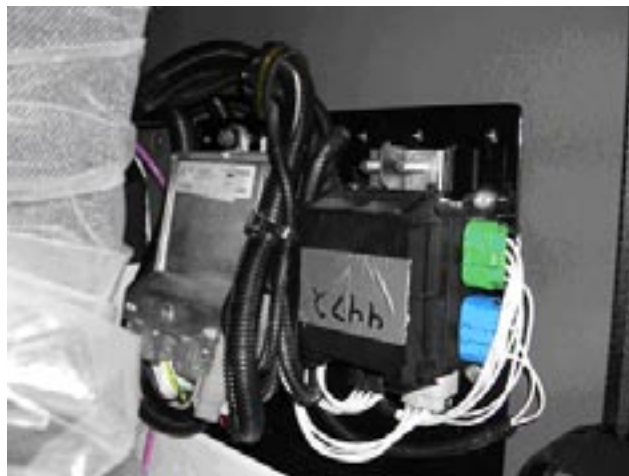
Figure 3

CORRECT ROUTING, WIRING ROUTED OVER TRANSMISSION ECU
