## SB 4-269-001

**SUBJECT: SECONDARY TRANSMISSION SHIFT CONTROLLER**

**MODELS: WX DUAL DRIVE AND WXLL DUAL DRIVE VEHICLES EQUIPPED WITH ALLISON 4th GENERATION TRANSMISSION CONTROLS**

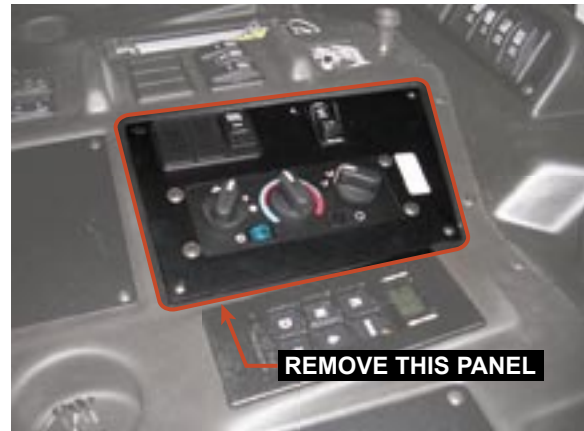
Figure 6

**NOTE:** IN *FIGURE 6*, THE CLIMATE CONTROL PANEL IS INSTALLED IN THE RIGHT SIDE (RS) BODY BUILDER PANEL. THE TRANSMISSION WIRE HARNESS THAT MUST BE ACCESSED IS LOCATED BEHIND THIS PANEL, BUT IT MUST BE NOTED THAT THE CLIMATE CONTROL PANEL MAY BE LOCATED ELSEWHERE, DEPENDING ON THE OPTIONS AND CONFIGURATION OF THE VEHICLE.

**STEP 1:** Remove right side (RS) front body builder panel to access the transmission shift controller harness (*Figure 6*).

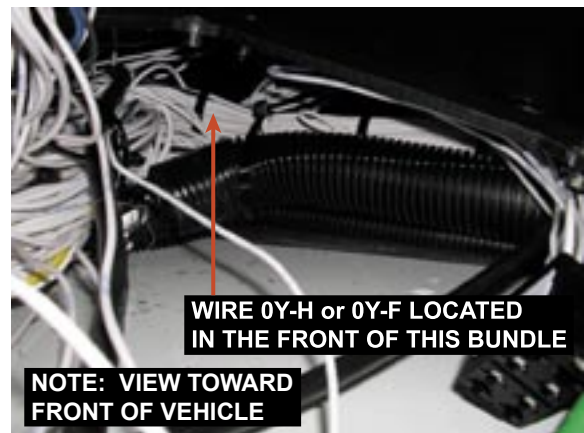
Figure 7

The root cause has been determined to be incorrect wiring within the transmission control wire harness. The ground wire for the secondary transmission shift controller is not grounded properly. Without being properly grounded, the secondary transmission shift controller will not function as intended.

**STEP 2:** Locate wire 0Y-H or 0Y-F, in the front bundle that routes to the Transmission ECU (*Figure 7*). Cut either wire at the most accessible location and strip both ends.
