SERVICE PROGRAM

SP 3-144-004

**SUBJECT: REPLACE INSTRUMENT
CLUSTER LIGHT BAR**

**VEHICLES AFFECTED: AUTOCAR ACX MODEL
VEHICLES BUILT BETWEEN 30
NOVEMBER 2007 AND
22 SEPTEMBER 2008, VIN
RANGE 206686 TO 208559**

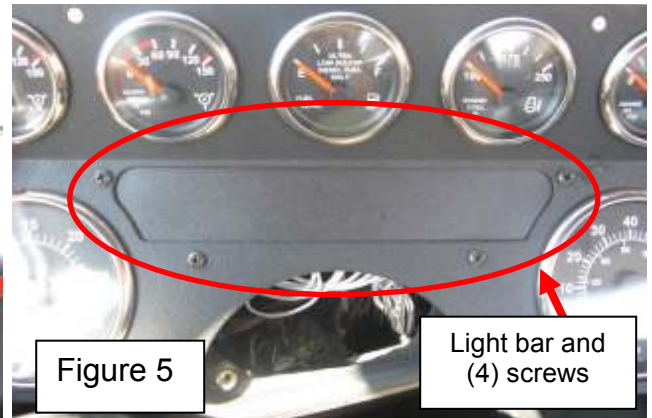
The instrument cluster light bar in certain Autocar ACX heavy duty class 8 vehicles has a software programming error which incorrectly causes the ABS trailer light to illuminate and stay illuminated. This program describes the procedure for replacing the light bar with the faulty programming.

5. Remove the A1441001-001 or A1441004-001 light bar from the instrument cluster by removing the (4) screws with a ratchet or Phillips screwdriver. See Figure 5 showing the light bar screw locations.

6. Install the A1441009-001 light bar to the instrument cluster with (4) screws and a Phillips screw driver.
7. Reinstall the (2) white harness connectors to the back side of the A1441009-001 light bar.
8. Reinstall the instrument cluster to the dash with (8) screws and a Phillips screw driver.
9. If the steering column bolts were removed, position the steering column back into the correct position and install the column bracket with (4) bolts.
10. Tighten the (4) steering column bracket bolts with a ratchet and 9/16" socket and torque the bolts to 30+/-3 Ft-lbs. with a torque wrench.
11. For an ACX dual-drive truck, move to the opposite side of the cab, and repeat Step 3 through Step 8 for the opposite side light bar.
