SB 3-873-001

SUBJECT: CERTAIN WX TRUCKS WHERE THE TECH PANEL SPACER WAS OMITTED DURING INSTALLATION

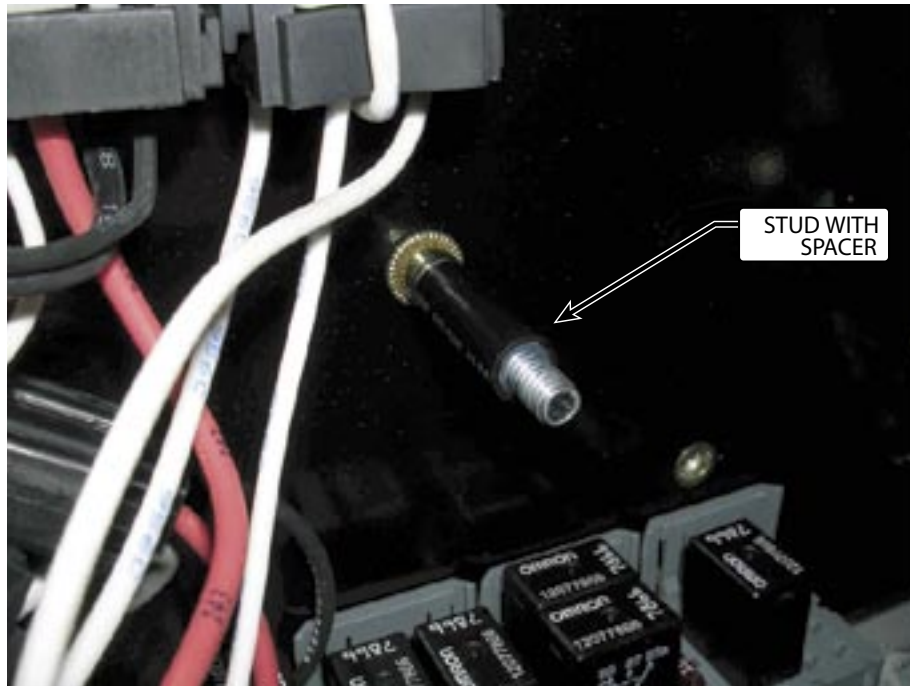
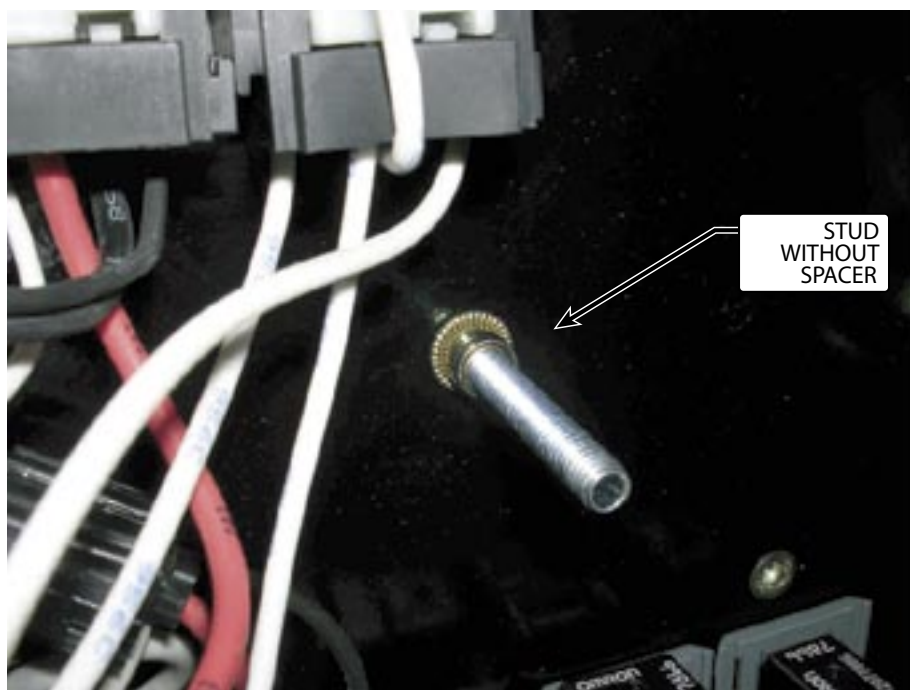
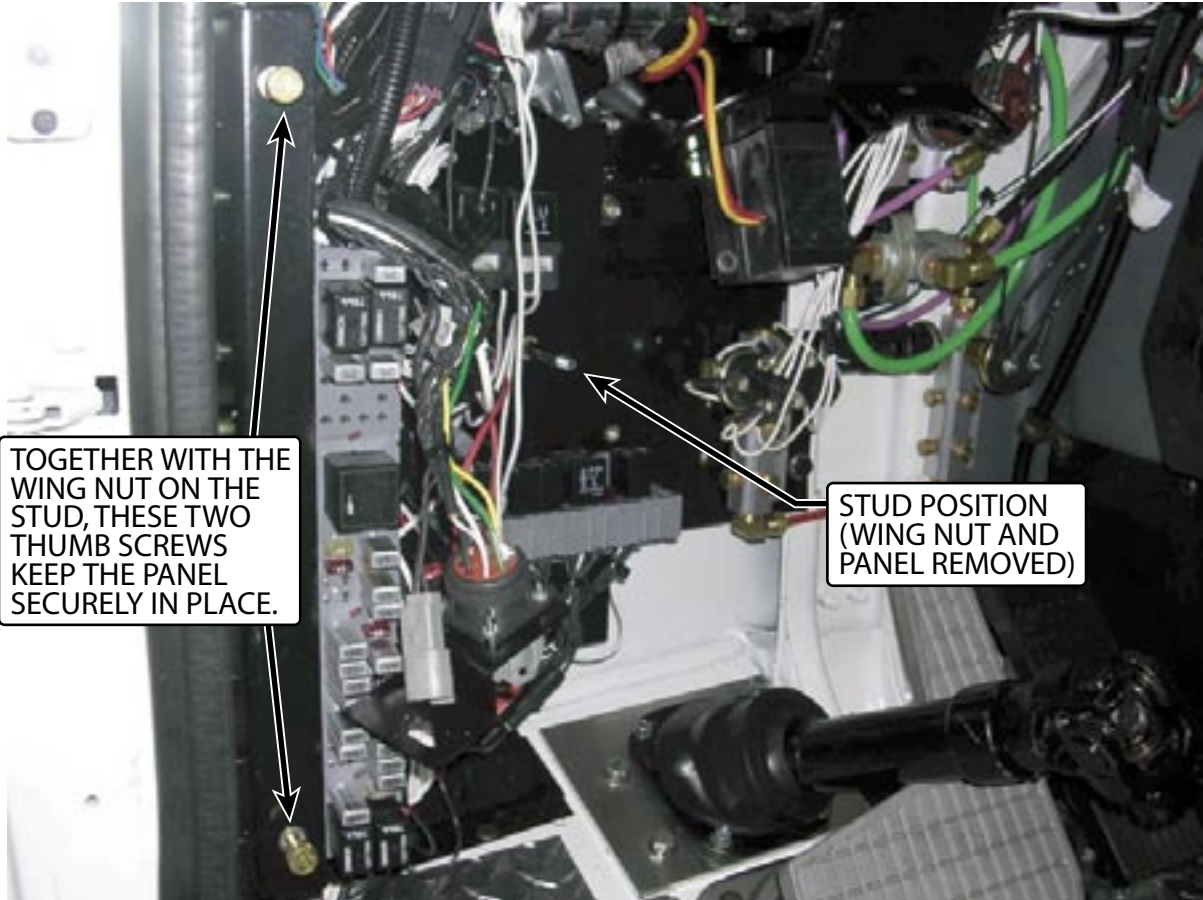
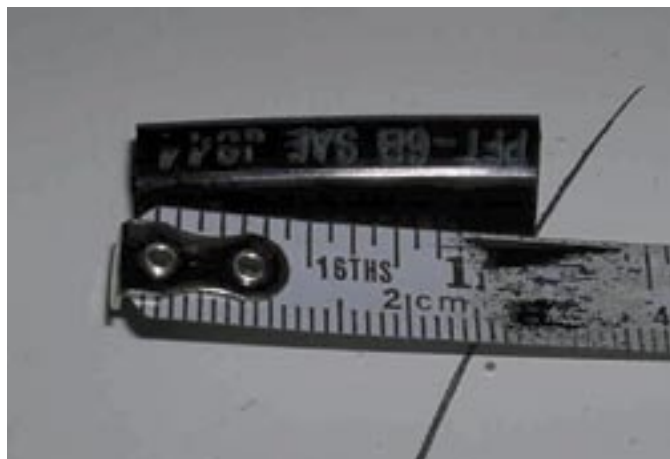
If this spacer has been omitted and the wing nut is over-tightened, the panel cover will contact the transmission control relays and could cause them to internally short circuit. Refer to included photos for more detail.

1. Park the vehicle on a level surface. Turn off the engine, apply the parking brakes, and chock the rear tires to keep the vehicle from moving.
2. Locate the Tech Panel. It is in the left-hand side of the cab, left of the steering column, under the dashboard.
3. Inspect the threaded stud where the spacer installed. If the spacer is not installed, remove the panel and inspect the relays for signs of deterioration.
4. If any relays are damaged, these should be replaced before installing the spacer and re-installing the Tech Panel cover.
5. Cut a section of plastic brake tube as described and install over the threads of the stud to which the wing nut is threaded.
6. Reinstall the Tech Panel cover and secure all three fasteners.
